Over Pressurization of Spin-On Filters

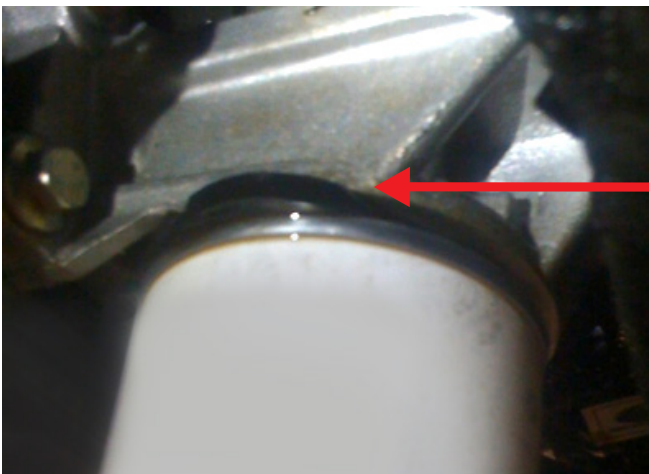
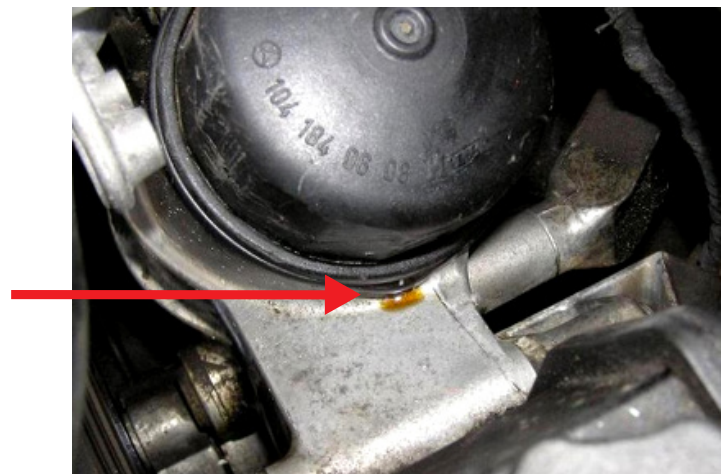
Occasionally after performing an oil and filter change, over pressurization occurs and causes oil leaks. Some of the potential symptoms may be that the gasket is bulging out and/or signs of deformation on the top of the filter can. This may occur:

- A. Right after installation, when checking for leaks an immediate very high pressure pushes the gasket out and a strong stream of oil leaks out.
- B. Leaks occur within several miles to few hundred miles of driving. The gasket bulges out, oil leaks and in some cases the can exhibits deformation on the top of the filter. (Images shown below.)

This condition is caused by excessive oil pressure (see attached bulletin). Over-pressurization is the result of malfunction in the operation of the check valve of the oil pump. The malfunction could mainly be a result of:

- 1. Mechanical failure of the oil pump - In such case part replacement is inevitable
- 2. Oftentimes this could be a result of residual deposits of "gunk" and heavy sludge may be dislodged from the oil pan and finds its way through the system. This may be addressed by flushing the engine *. At that point, it is recommended that an engine flush be utilized to remove those deposits from the engines ball & spring oil pressure relief valve as well as the rest of the system.
